# Nor848A Acoustic camera

## Identifying Low-Frequency Tonal Noise in Windy and Noisy Conditions

### Measurements on LNG gas terminal in Stavanger, Norway, September 2014

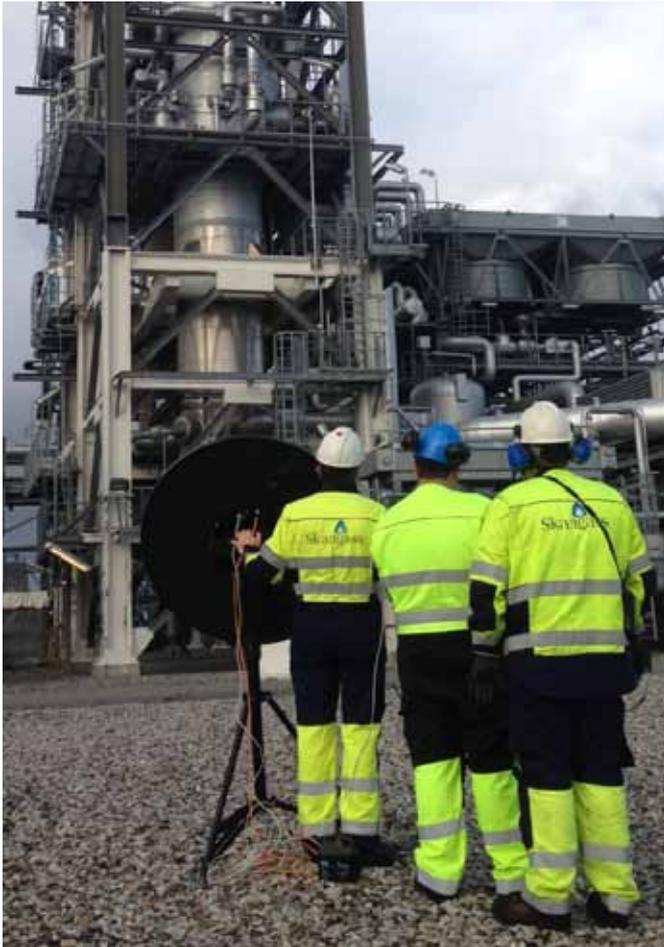
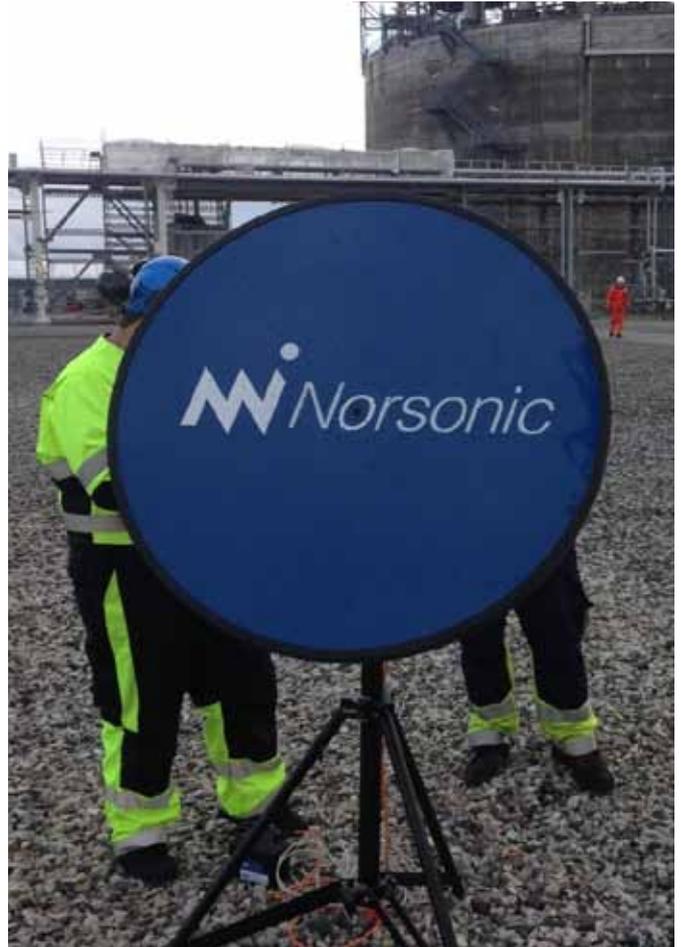
The measurements were conducted over two subsequent days with the Nor848A-10 1.0m and 256 element acoustic camera. The camera was plugged into an external battery pack for easy transportation and mobility. The entire measurement system could easily be moved around to different positions to get a noise mapping of different sides of the pipe. Different positions would also ensure that noise sources being different from the source of interest would

not inflict too much on the measurements. The primary measurements were conducted at a distance of approximately 25-30 meters from the pipe. In addition measurements were made close to the source from 2-5 m distance by climbing up onto the pipe with the camera. Since the flight of stairs were too narrow to get the 1.0 m camera through the stair's safety rails, this was solved by hoisting the camera up and down by rope.

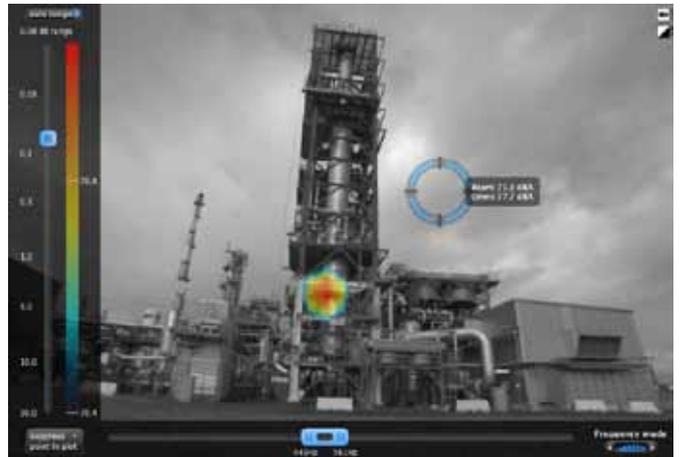
By positioning the center of the array towards the pipe and adjusting the frequency to display only coloring within the 500 Hz 1/3-band, the noise source was located within seconds, and the source producing the tonal part from the pipe was detected. Measurements from different measurement positions also confirmed the source location.

By placing the virtual microphone on the localised source and using the spectrogram function, it was easy to verify the position of the source emitting a tone at 460 Hz.

Although the measurement location had quite windy conditions, the wind noise did not affect the measurement re-

sults at all. Wind noise can be viewed as spatially white, which means that wind noise sampled at different places in space, as is done with the Nor848A, is not correlated from position to position. When many different signals from many microphones are added in the beamforming algorithm, the wind noise will be added out of phase and attenuated proportional with the number of microphones being used.

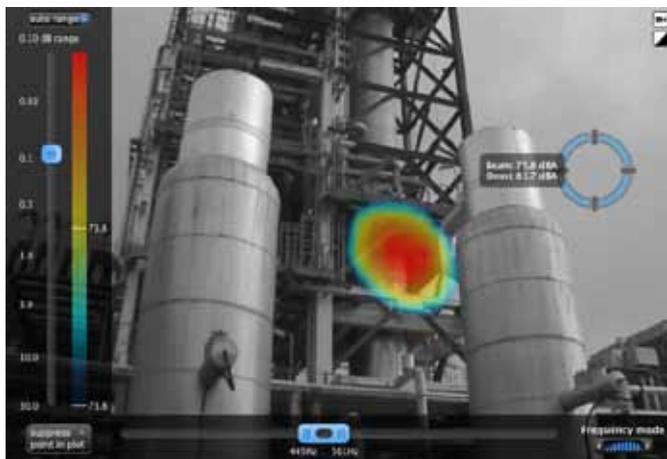
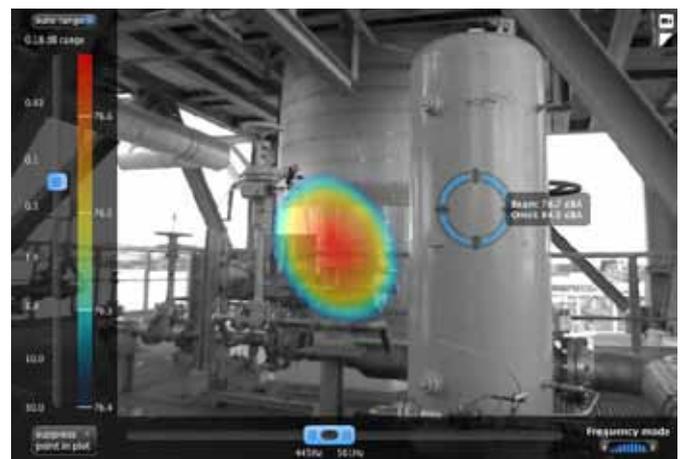
After pin pointing the location of the noise source, further analysis could be made with measurements performed closer to the source of interest in order to further determine the position and cause of the generated tonal noise.

With the acoustic camera it was possible to detect the tonal sound of the most crucial parts of the turbine. This meant that the facility could focus on and implement noise reduction actions in the right places.

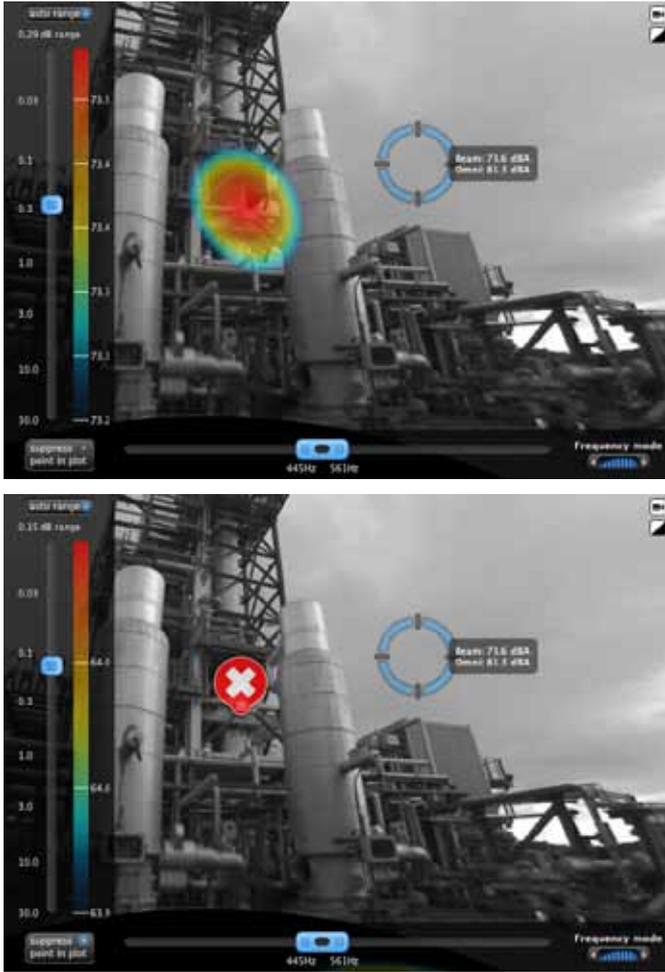
disc-shaped carbon fibre enclosure, and a dust and water repellent mesh is protecting the microphones from dust and moisture. The robust and sturdy construction also ensures that all microphones are kept in the correct position – important for field applications. The small distance between the microphones in the inner circle is important for low spatial aliasing at higher frequencies. The large number of microphones also contributes to the wide measurement range and the low self-noise. The signal in the selected direction is based on the weighted average of all microphones and is therefore far below the self-noise from a single microphone.

The digital microphone elements are protected behind a

The Nor848A software is extremely intuitive and easy to use. Just after a few minutes of training, the user is able to operate the system and do real measurements. Three camera frontends are available, all varying in number of microphone sensors and size, where a larger array size ensures better resolution for lower frequencies: A 0.4 meter array holding 128 microphones, a 1.0 meter array holding 256 microphones and a 1.6 meter array with 384 microphones.
